Precision isolation restores well integrity; Expro ReLine MNS replaces compromised patch in single trip

Objectives and background

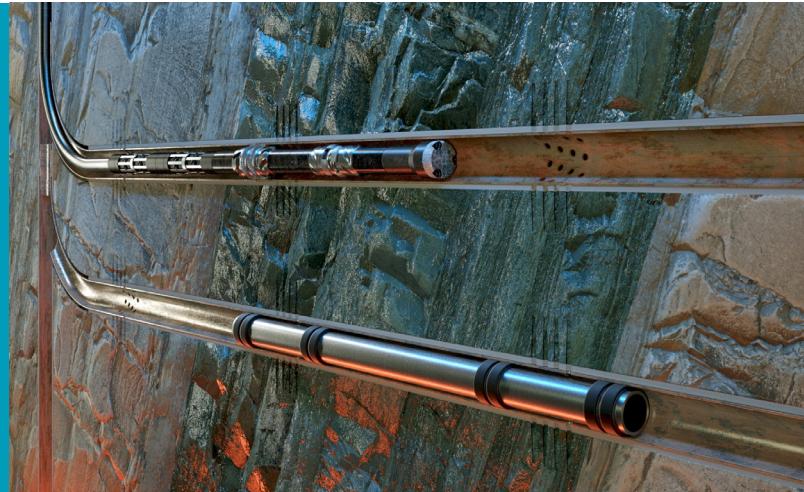
- We designed bespoke tools which were tailored to the well's unique specification
- Our ReLine MNS swiftly energised seals in the 7" casing below while anchoring them securely in the 7" casing above. Our tool effectively isolated the 7-5/8" perforated casing which been plagued by a leaking patch. With the patch in place, the well held its integrity and leak was gone

- Expro deployed our ReLine MNS system, this provided a single all-encompassing solution that not only rectified the leak but also did so with unparalleled efficiency and cost effectiveness
- A true single-trip mechanical system that eliminates the need for a shoe, removing the entire drill out requirement
