# Detection of external corrosion in 7-Inch production casing Using Multi-Finger Caliper and MTD Integrity Logs

## Well Intervention and Integrity

### Objectives and background

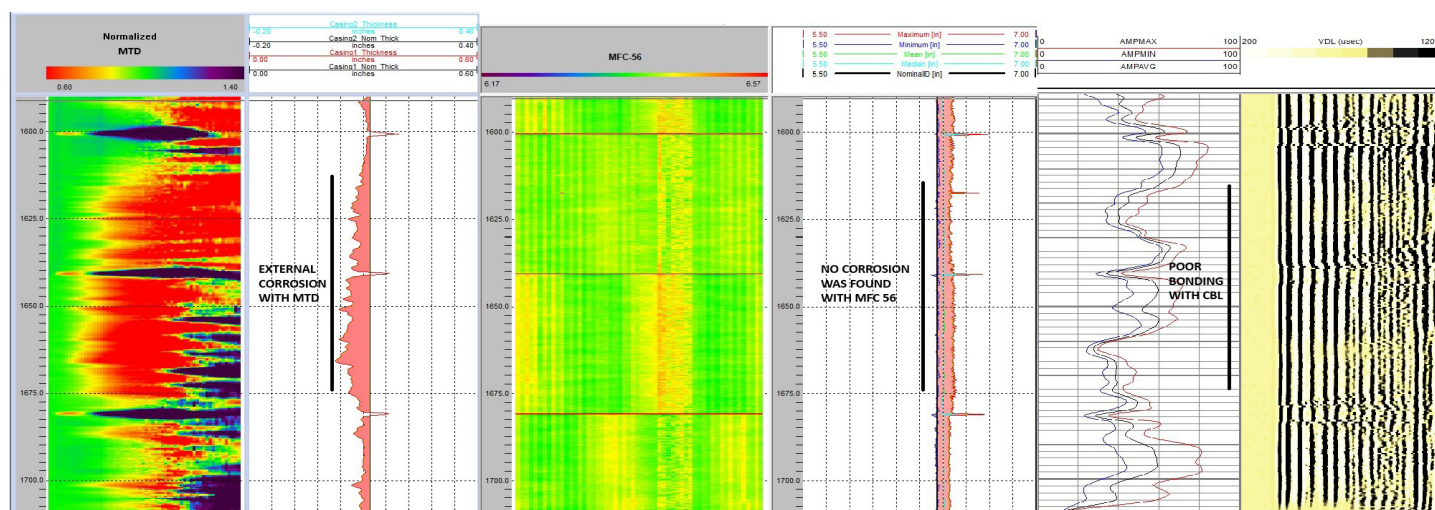
- Expro deployed an integrated well integrity evaluation combining Multi-Finger Caliper (MFC), Magnetic Thickness Detector (MTD), Cement Bond Logs (CBL/RBT), and temperature measurements in a single logging run. This enabled a complete assessment of casing geometry, wall thickness, fluid movement, and cement quality
- By correlating data from multiple technologies, Expro successfully distinguished between internal and external corrosion mechanisms. The analysis identified internal corrosion, pitting, localized holes, and deformation along the casing, while also revealing a critical interval (1615–1675 ft) where severe external corrosion and metal loss of up to 28.62% existed despite the internal casing wall appearing intact. Poor cement bonding and fluid movement were also identified as contributors to the external corrosion

- Expro delivered a comprehensive understanding of casing integrity through a single, integrated logging operation
- Identified critical external corrosion that would not have been detected using caliper measurements alone
- Enabled clear differentiation between internal corrosion, external corrosion, and mechanical deformation. Provided actionable data for targeted remediation, integrity management, and maintenance planning
- Reduced operational risk by identifying a potentially serious casing integrity threat before failure occurred. Improved confidence in decision-making, helping extend asset life and optimize intervention costs
